Updating your computer and Multi to VEConfigure3

v9 – March 15th 2013

Introduction to VEConfigure3

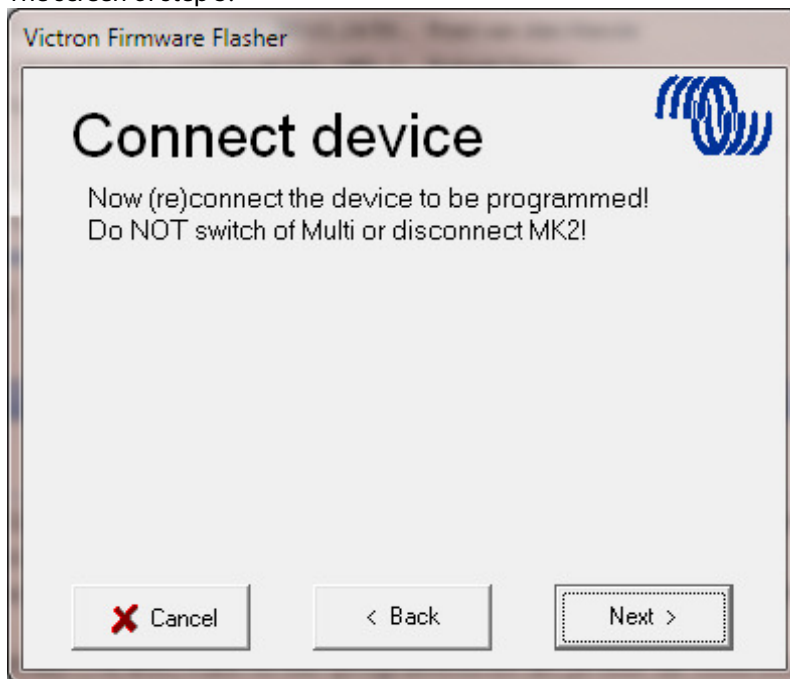
The screen of step 5:

At step 5 of above procedure, first connect the MK2.2a to the VE.Bus cable. Then create a short-circuit between the two pins indicated by an arrow. Touching both pins with a simple screwdriver will do the job, the short needs to be there only very briefly. Remove the short circuit before pressing "Next".
